YORKE PENINSULA COUNCIL

COASTAL MANAGEMENT STRATEGY

- HICKEYS POINT TO CORNY POINT -

2019

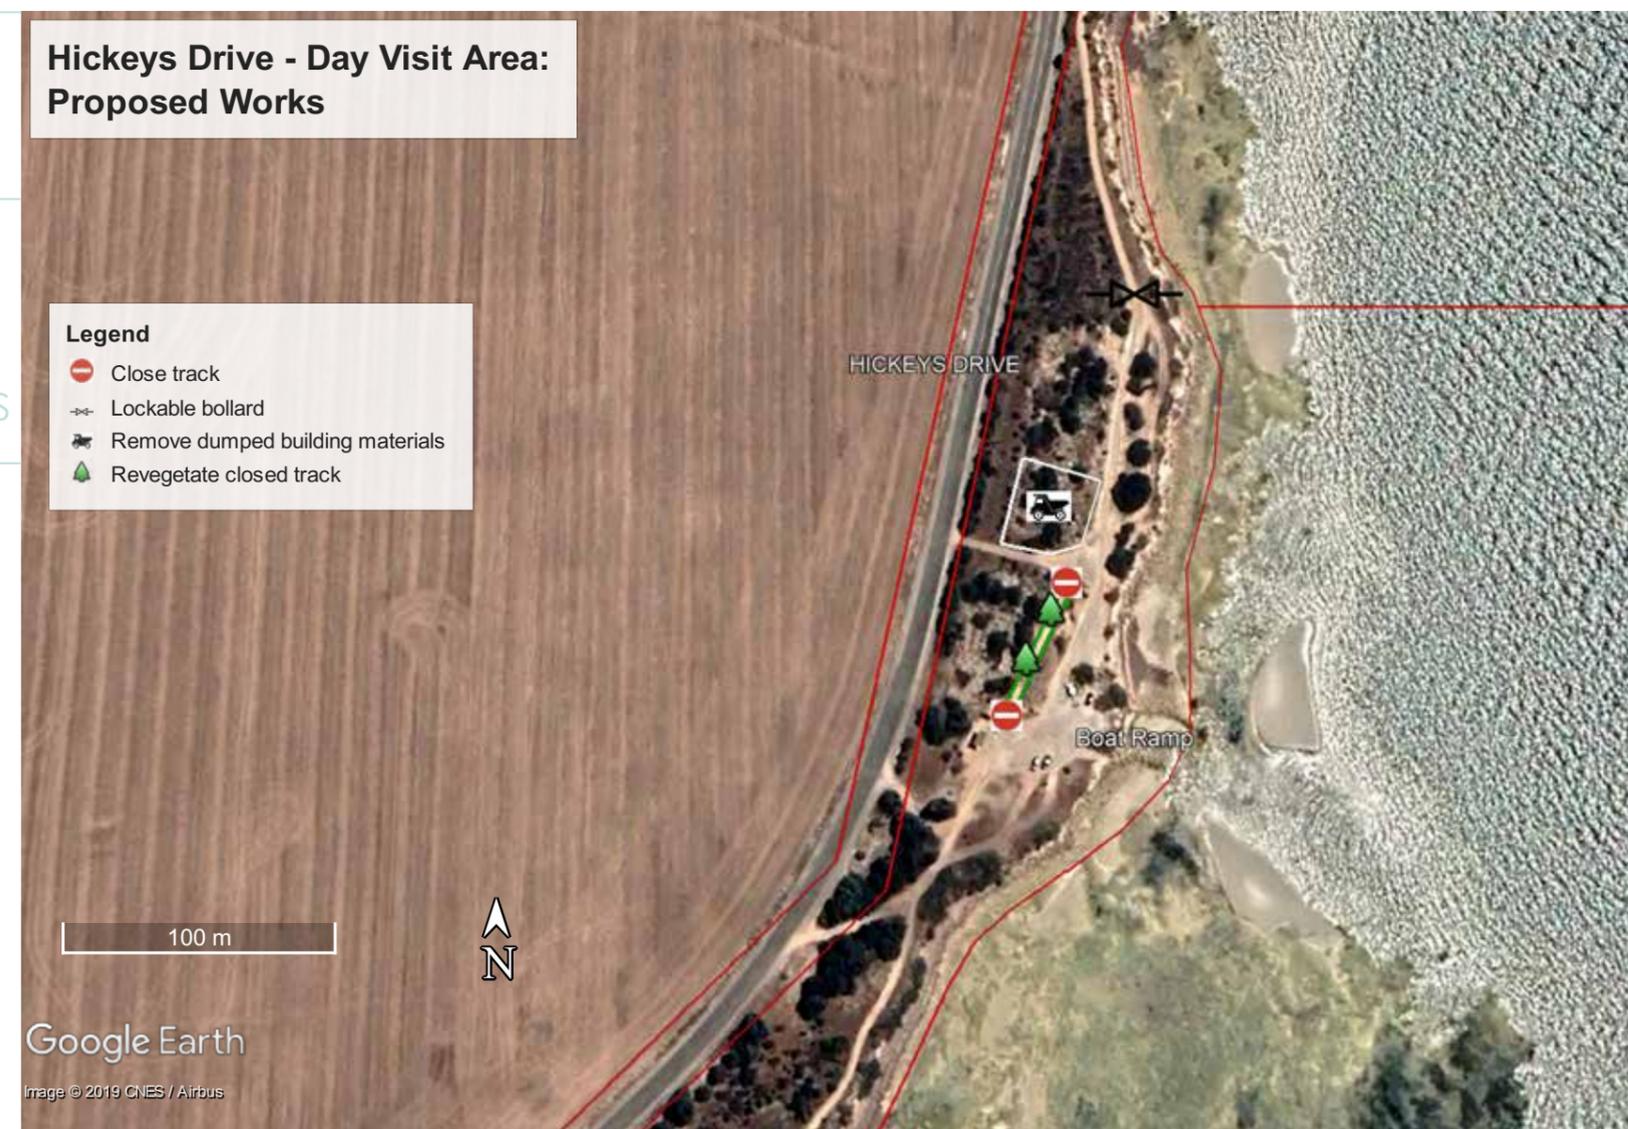
Hickeys Drive: Proposed Works**Legend**

Weeding + revegetation in high density weed areas

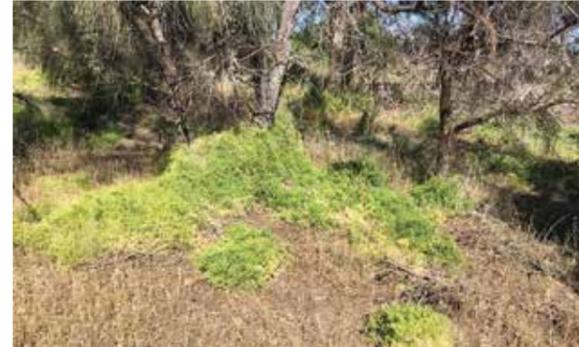
Bridal Veil along walking trail

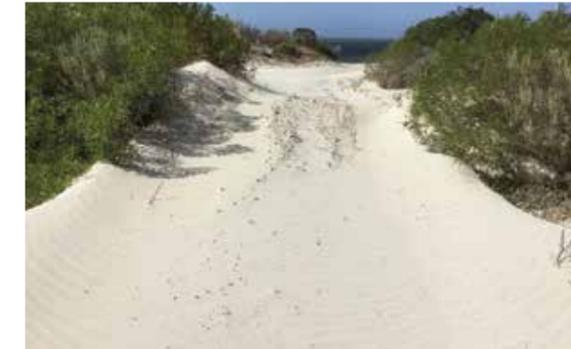
Track on Heel Road/Wattle Point Road intersection

Adjoining reserve	<ul style="list-style-type: none"> Close and revegetate the western section of the double track at the intersection of Wattle Point Road and Heel Road as it is susceptible to sand dune drift (30 tubestock) Replace Coastal Moor (<i>Eucalyptus utilis</i>) with native species as it dies Monitor small pull-off areas west of campground. Currently low impact
--------------------------	---

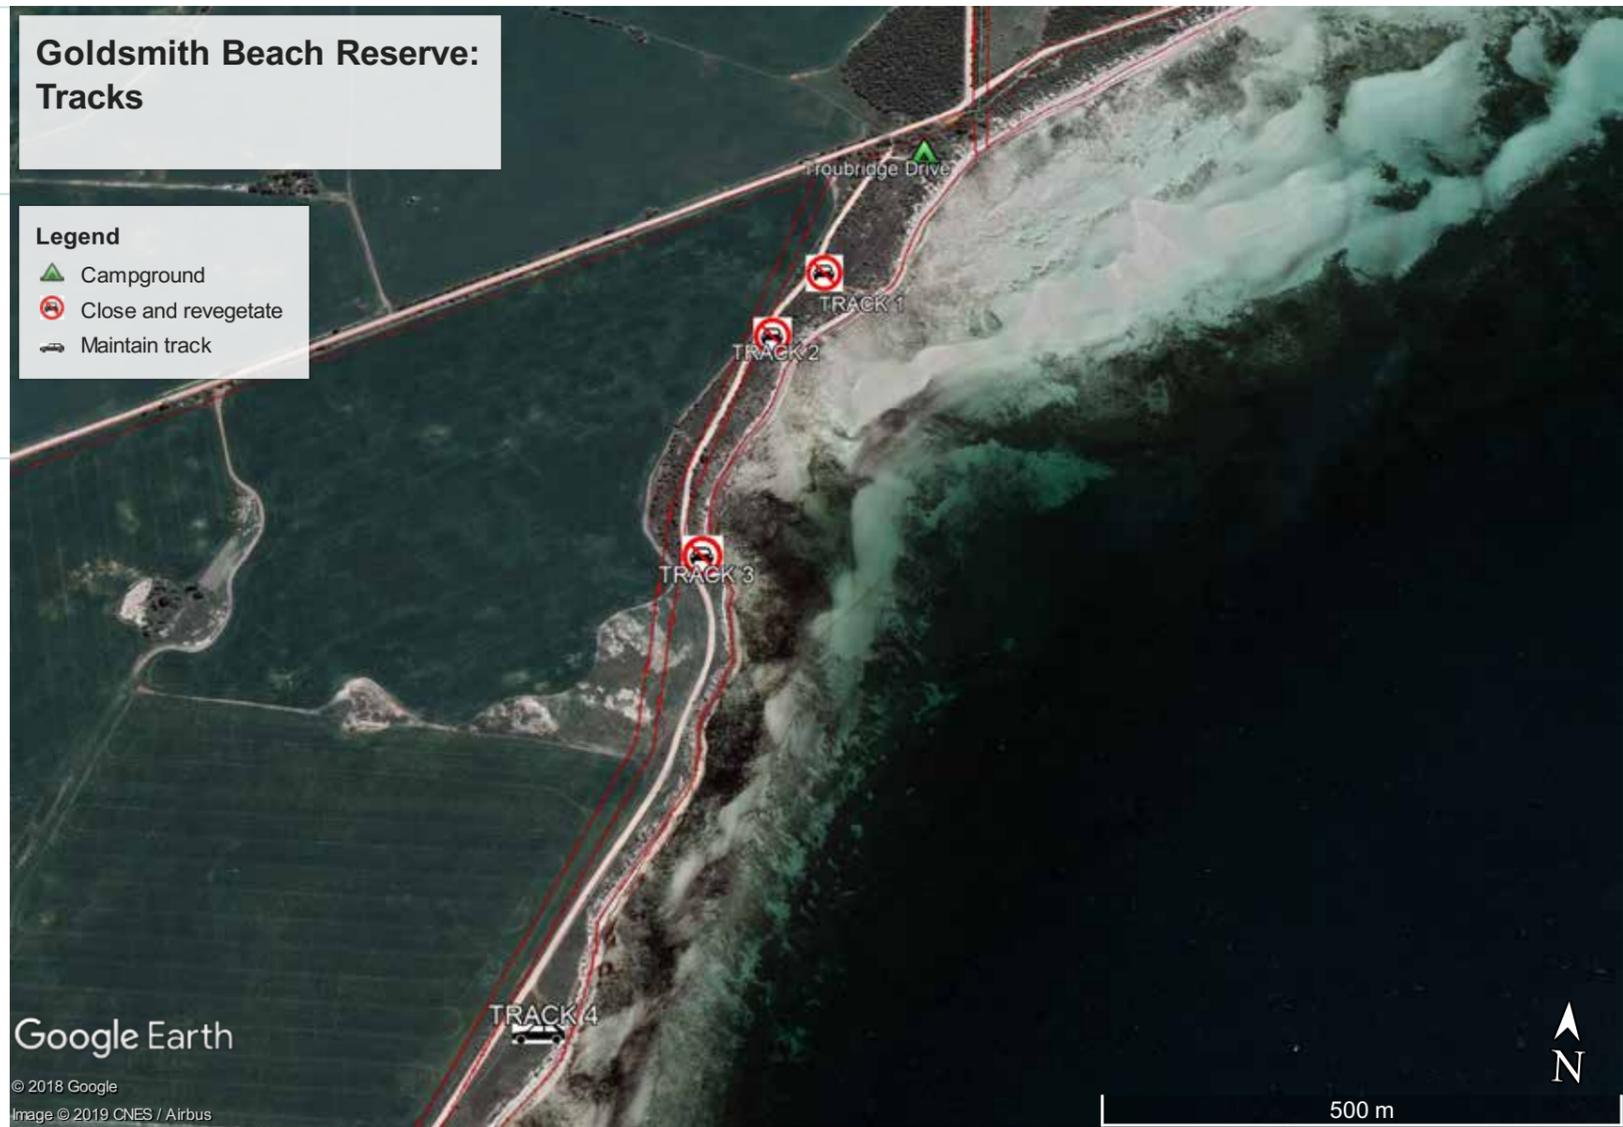
Goldsmith Beach Reserve Proposed Works: Track 1 and 2

- Legend**
- Boulders
 - Close track
 - Revegetate closed track

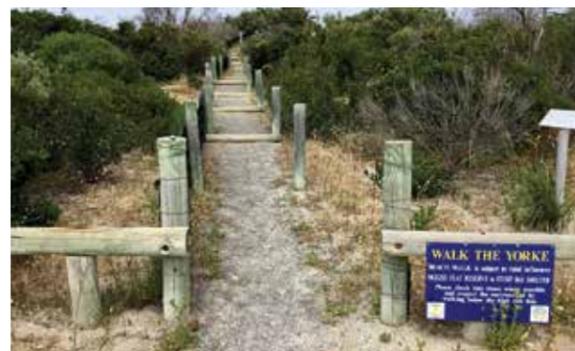
Beach access and fencing

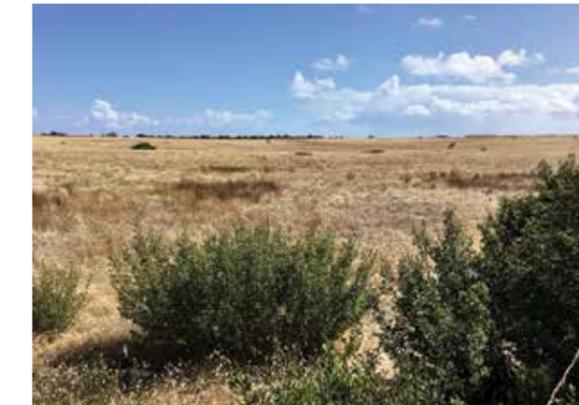
Area for proposed revegetation

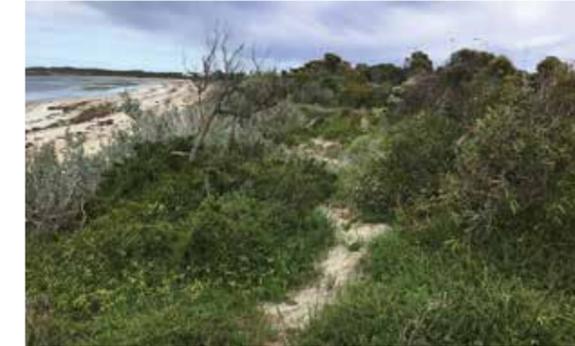
Weed infestation

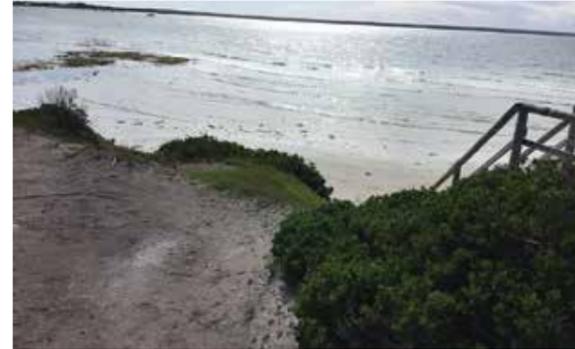
Old steps and area for platform and new steps

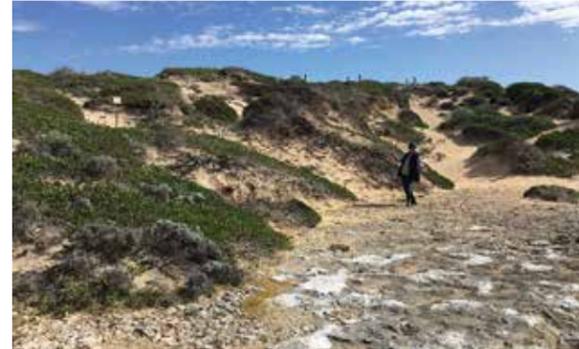
Degraded areas/goat tracks Penguin Point

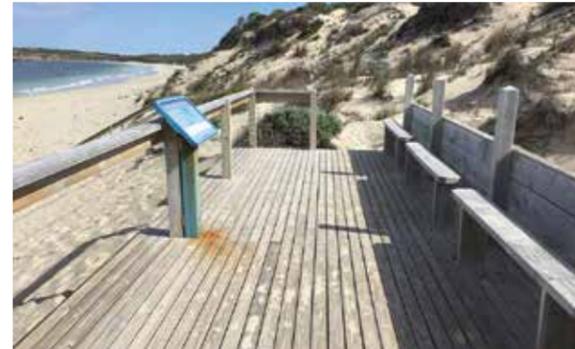
Boardwalk from platform Eastern Willyama Reserve

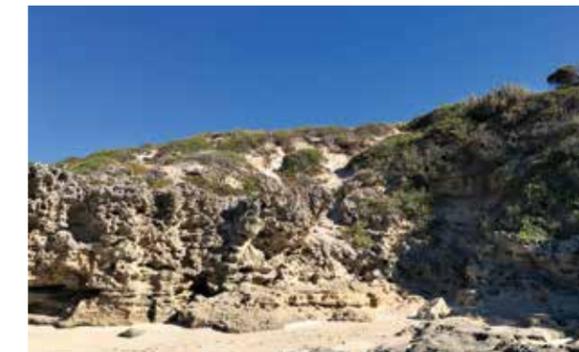
Staircase access to beach recommended

Summary of Site Recommendations	<ul style="list-style-type: none"> • Wooden boardwalk and staircase access to beach • Formalise and level car park with road base

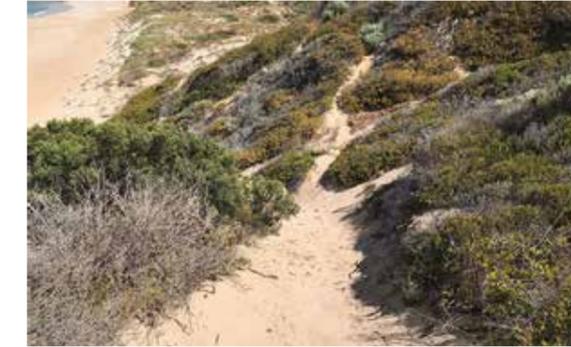
Boardwalk and staircase access required at Trespasser's Beach

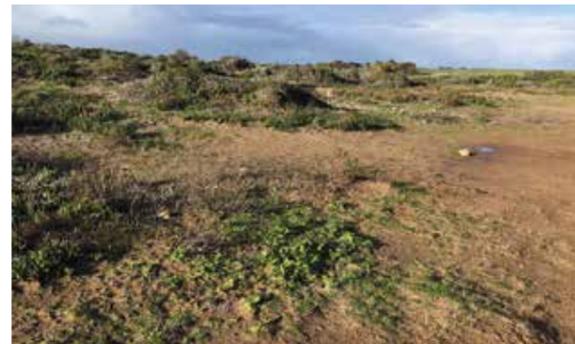
Northern end of campground

Summary of Site Recommendations	<ul style="list-style-type: none"> Formalise campsites, border with rocks and indigenous tubestock where possible (rocky site) Fence vegetation at northern end of campground, approximately 75 metres. Plant a Nitre Bush and Coast Daisy-bush as a wind break on mound at beachfront campsite. Revegetate adjacent track and degraded boundary (100 tubestock) Compost toilet with rain water tank at entrance Appropriate speed limits implemented

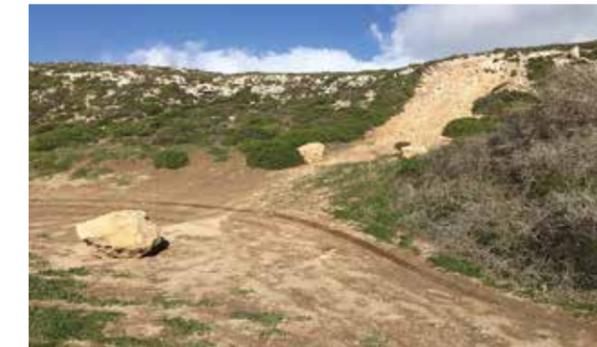
Northern beach site with dune damage
